Philips Domestic Appliances and Personal Care

# Service Manual

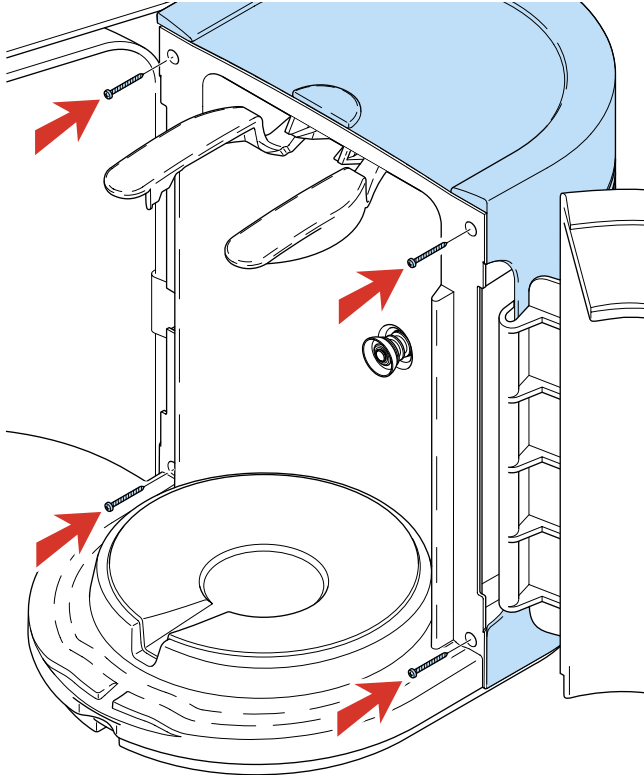
Picture 1.

- To remove the rear case, first remove the 4 screws.
- Open both doors, at the upper/lower right and left side the screws can be found..

- When the rear has been removed all parts can easy be reached.

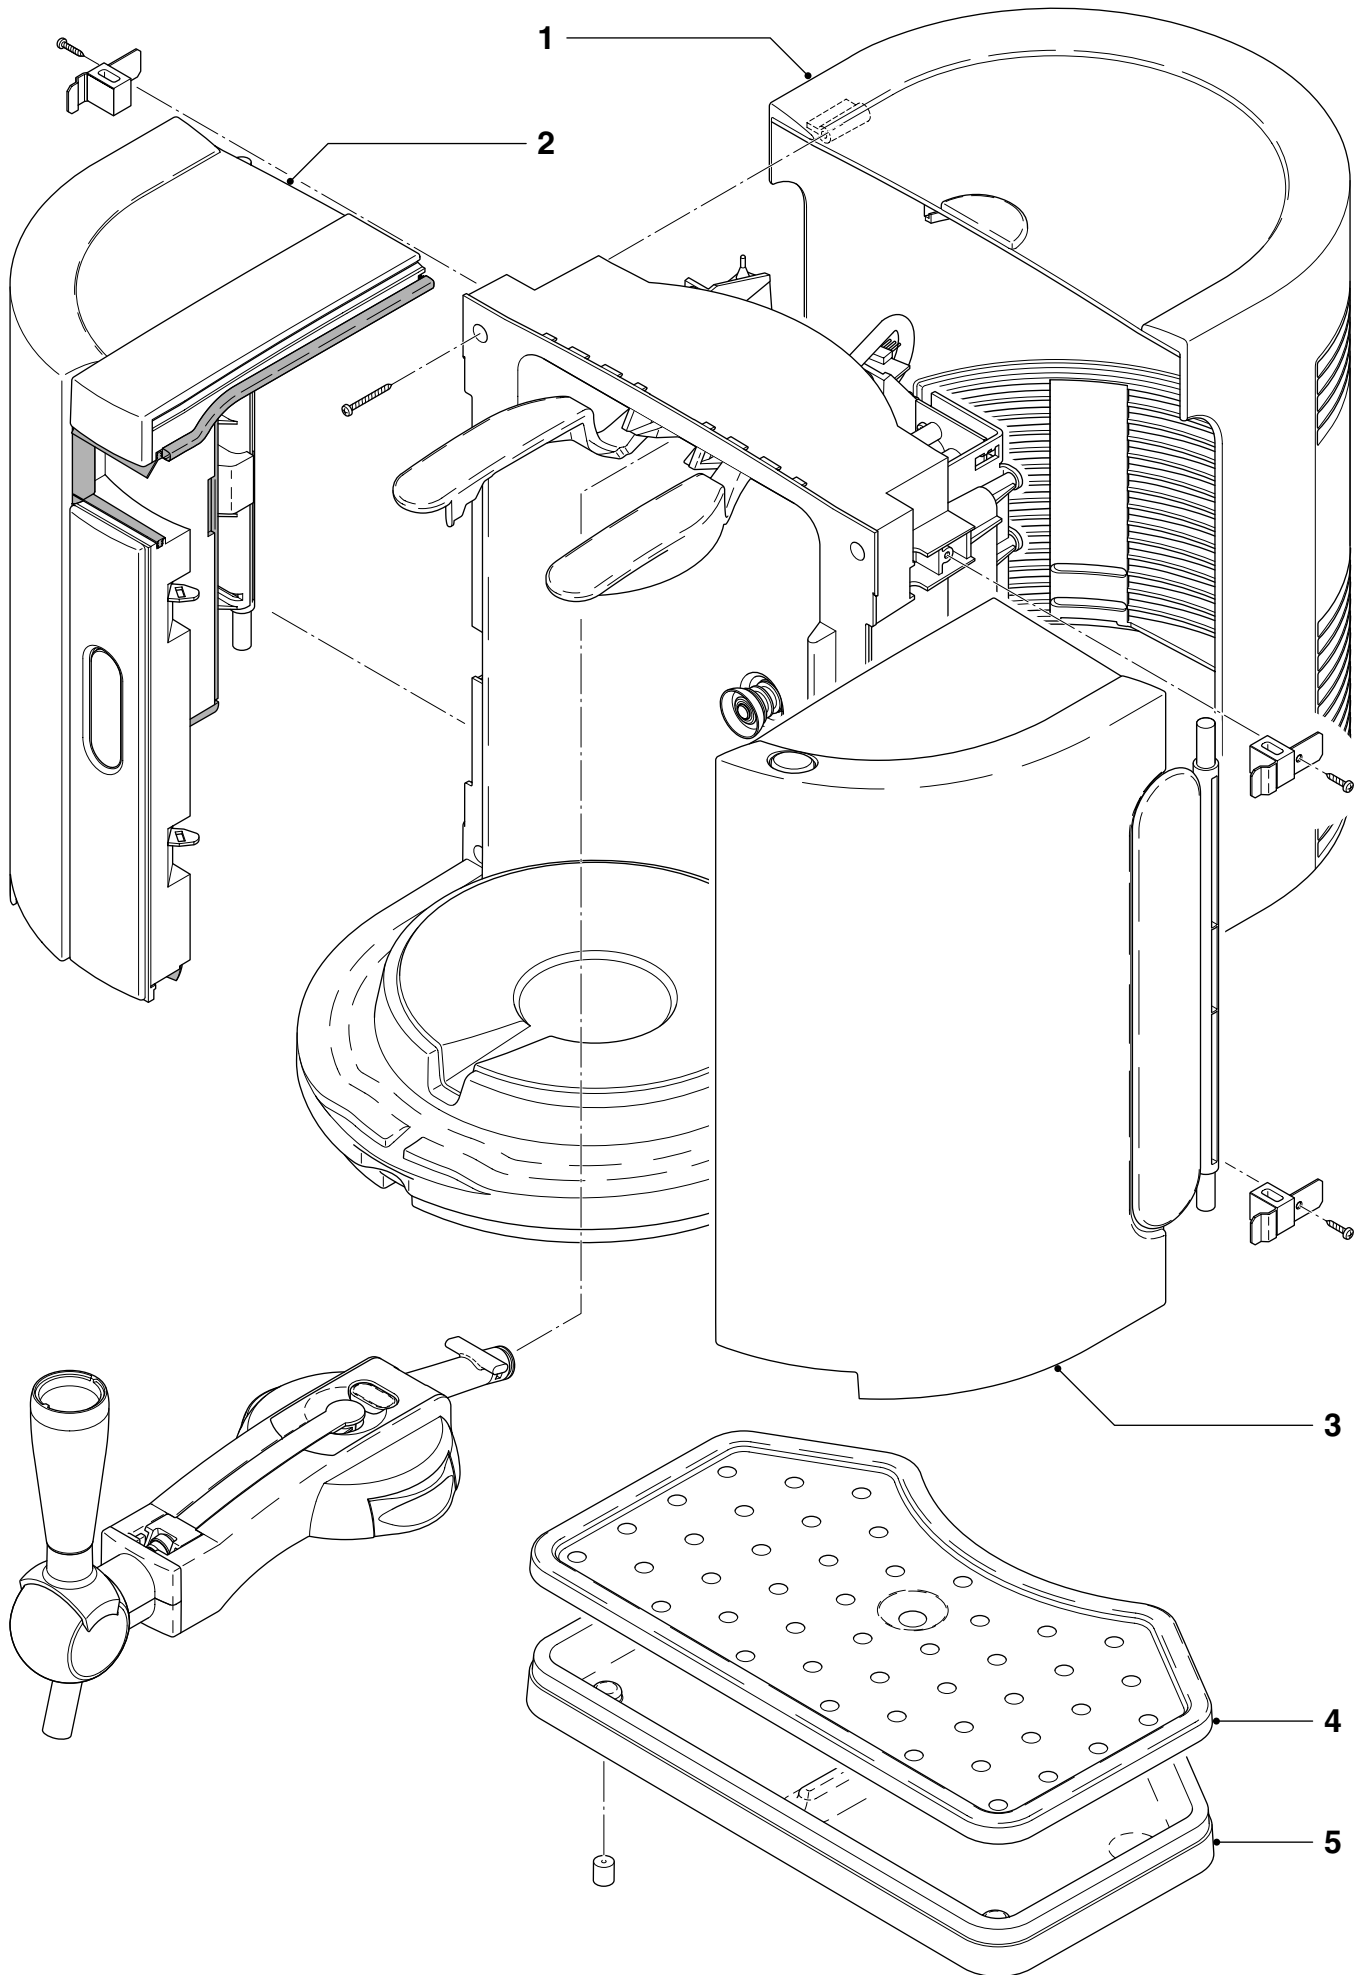
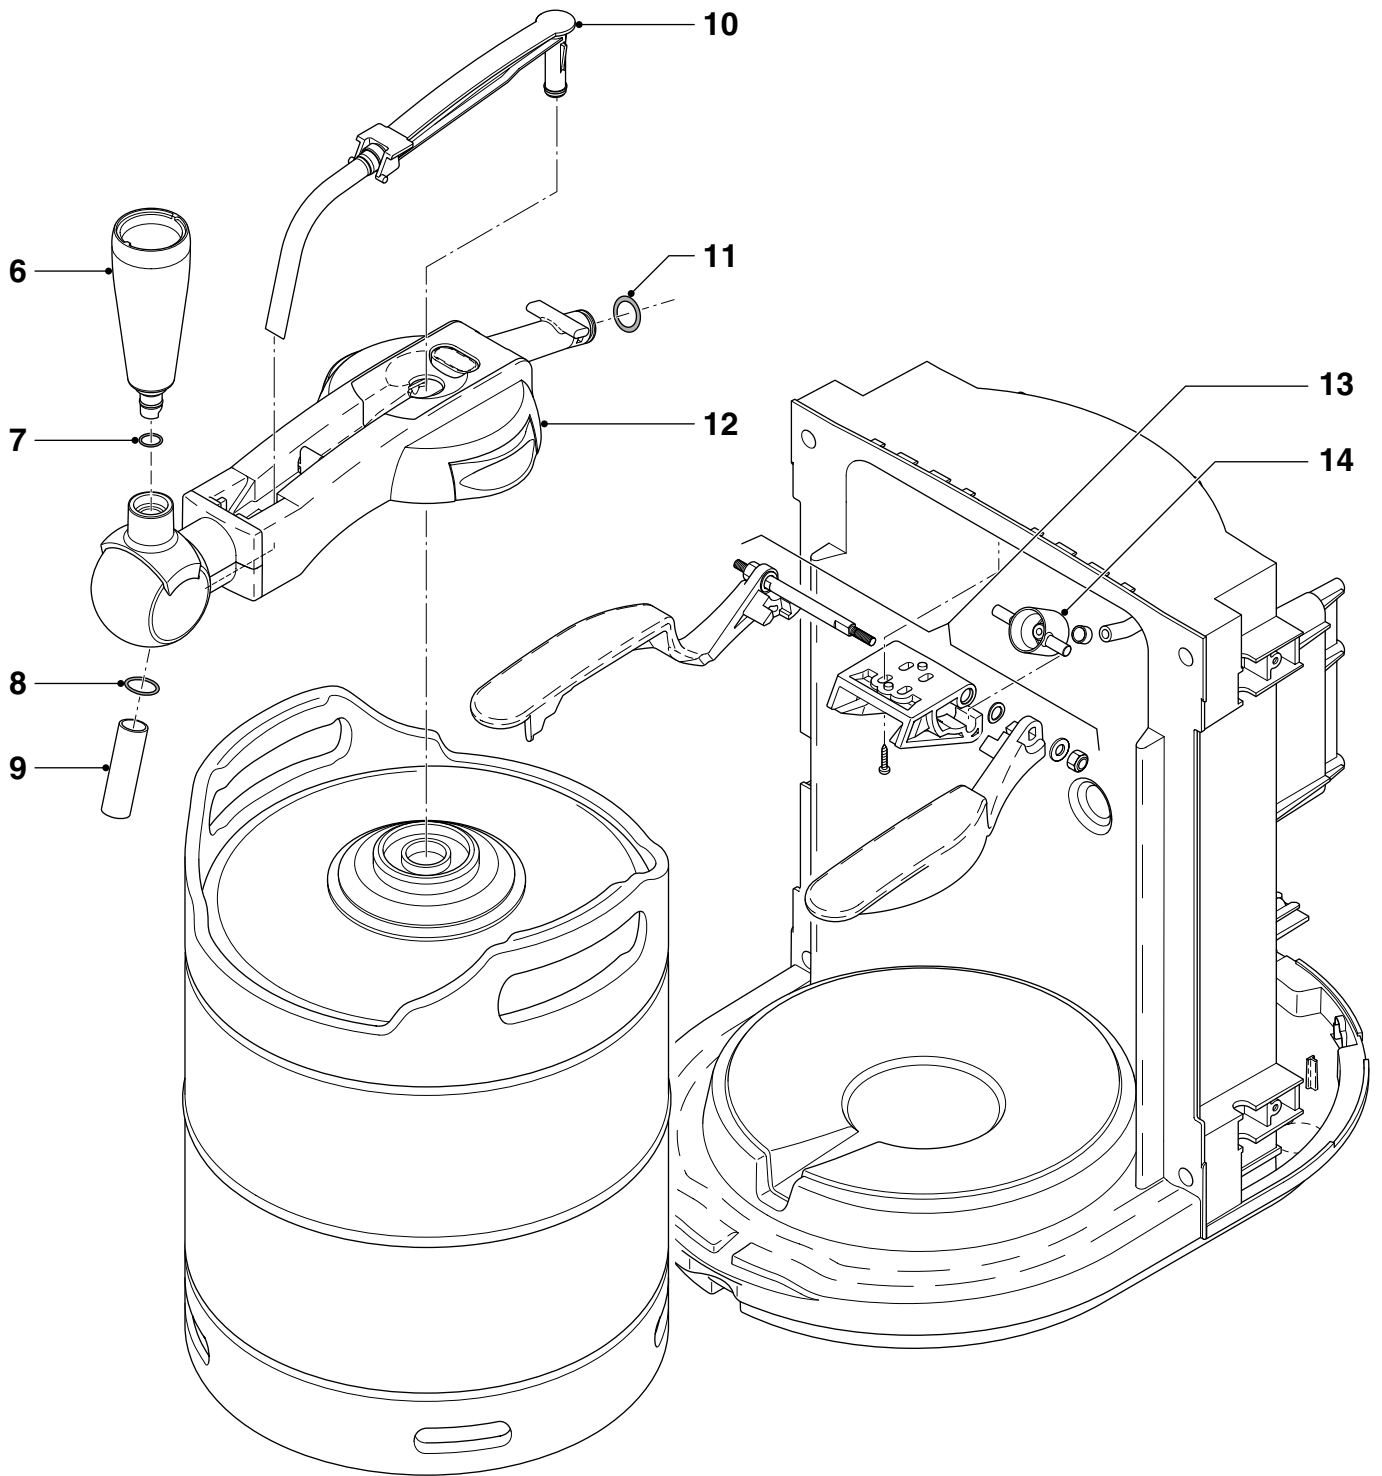
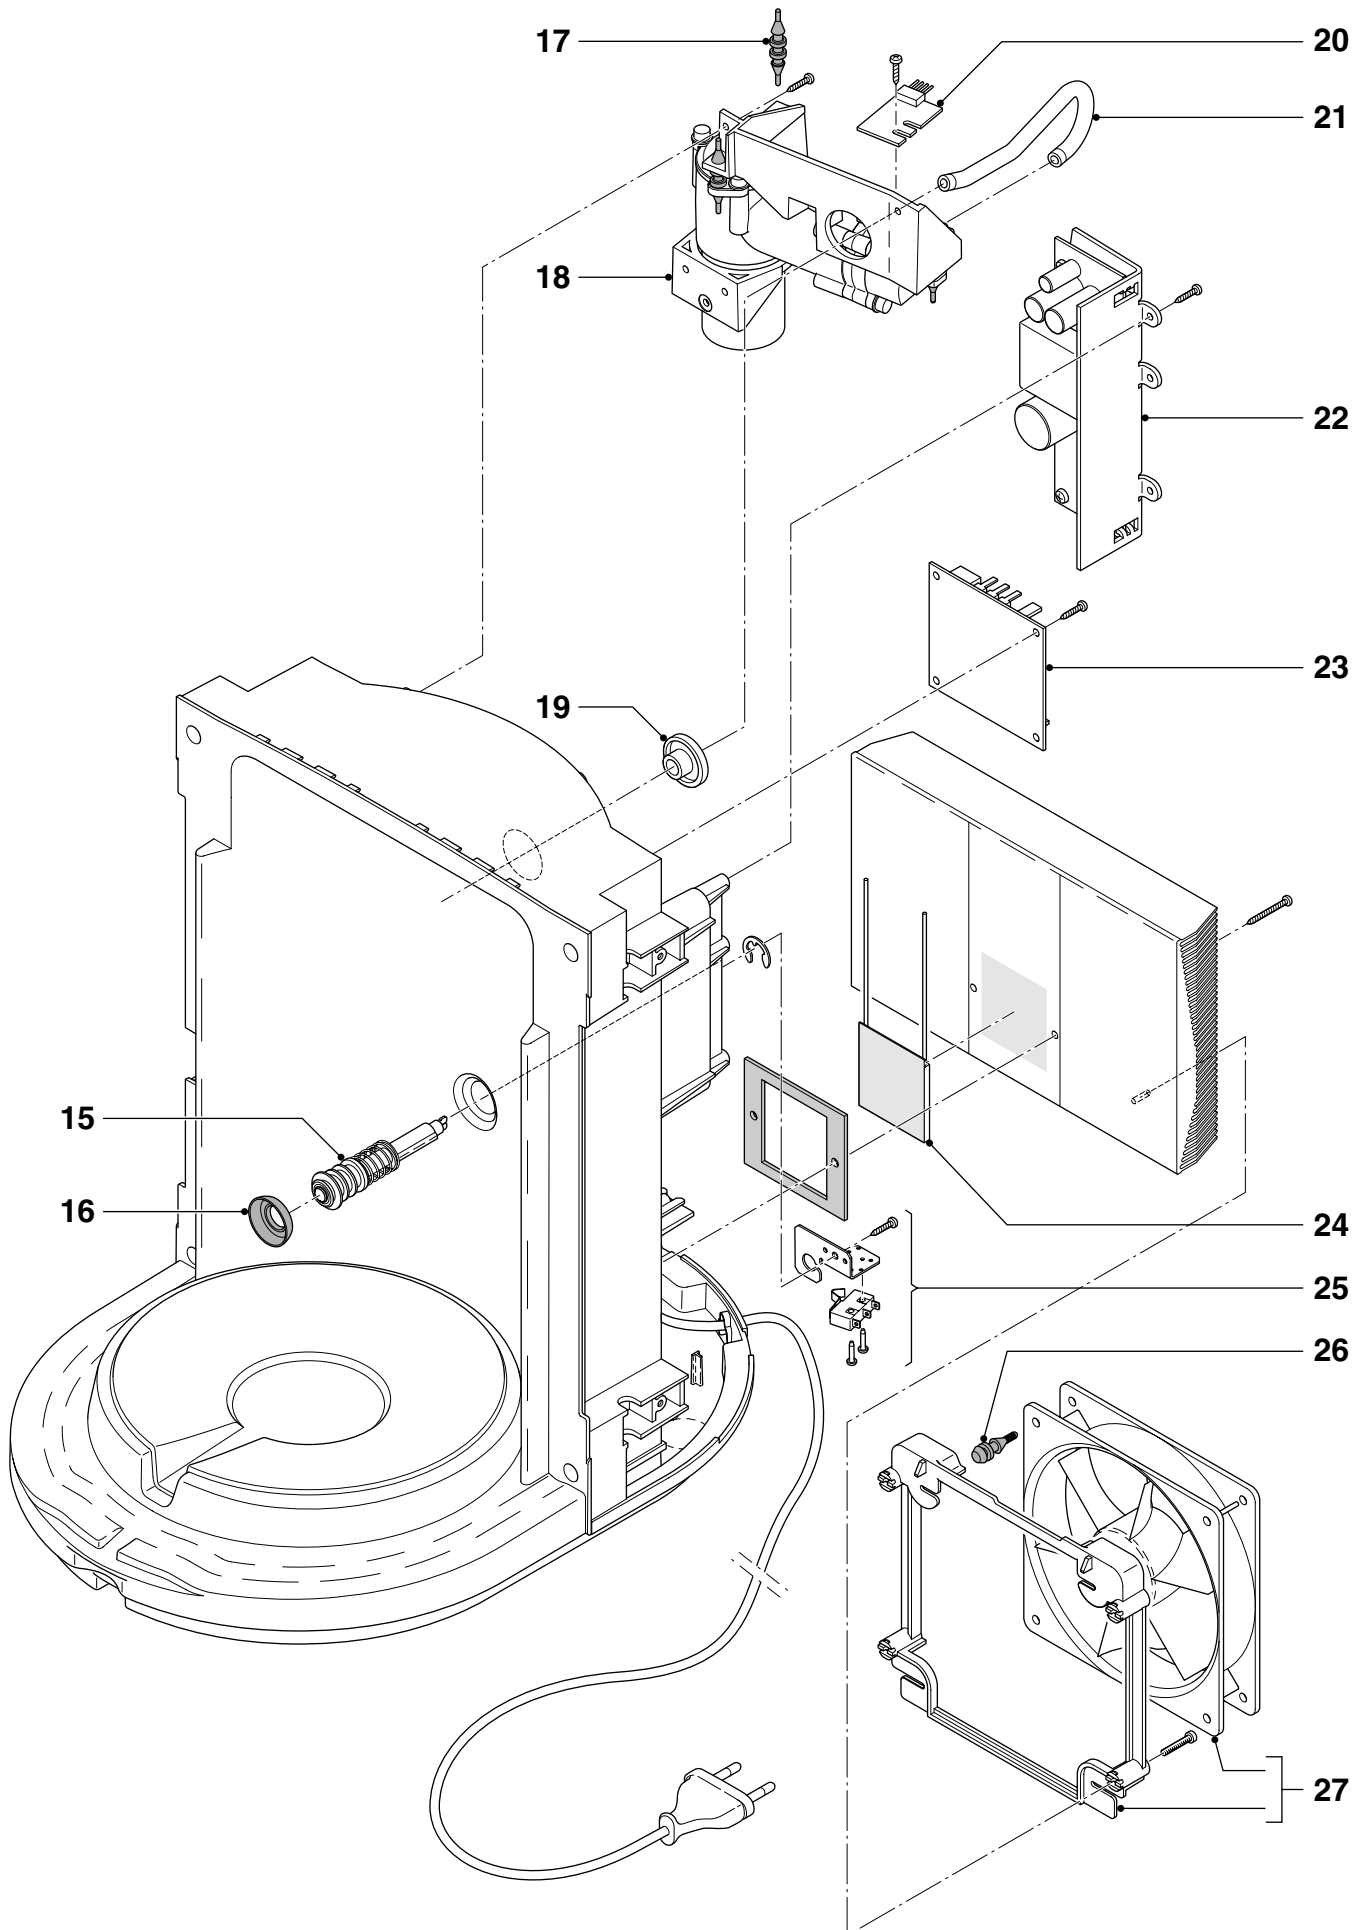
Pos	Service code	Description
1	9965 000 26106	Rear case assy
2	9965 000 26113	Left Door/display assy
3	9965 000 26114	Right Door assy
4	9965 000 26107	Steelplate driptray
5	9965 000 26108	Baseplate Driptray
6	9965 000 26121	Handle assy
7	9965 000 26122	Handle O-ring
8	9965 000 26124	Spout O-ring
9	9965 000 26123	Spout
10		Tube connector
11	9965 000 26126	O-ring 11X2 Air inlet side
12	9965 000 26125	Tap unit
13	9965 000 26129	Connector/Lever assy
14	9965 000 26130	Air coupling
15	9965 000 26127	Sensor assy
16	9965 000 26128	Skirt
17	9965 000 26115	Grommet. Pump position
18	9965 000 26116	Pump assy
19	9965 000 26131	Seal
20	9965 000 26117	Pressure sensor PCB assy
21	9965 000 26118	Pressure hose assy
22	9965 000 26120	Power supply HV 220-240V
23	9965 000 26112	Main PCB
24	9965 000 26119	Peltier assy
25	9965 000 26111	Micro switch assy
26	9965 000 26110	Grommet, FAN position
27	9965 000 26109	Fan assy
